TECHNICAL REPORT REMR-CO-3

CASE HISTORIES OF CORPS BREAKWATER
AND JETTY STRUCTURES

Report 7

NEW ENGLAND DIVISION

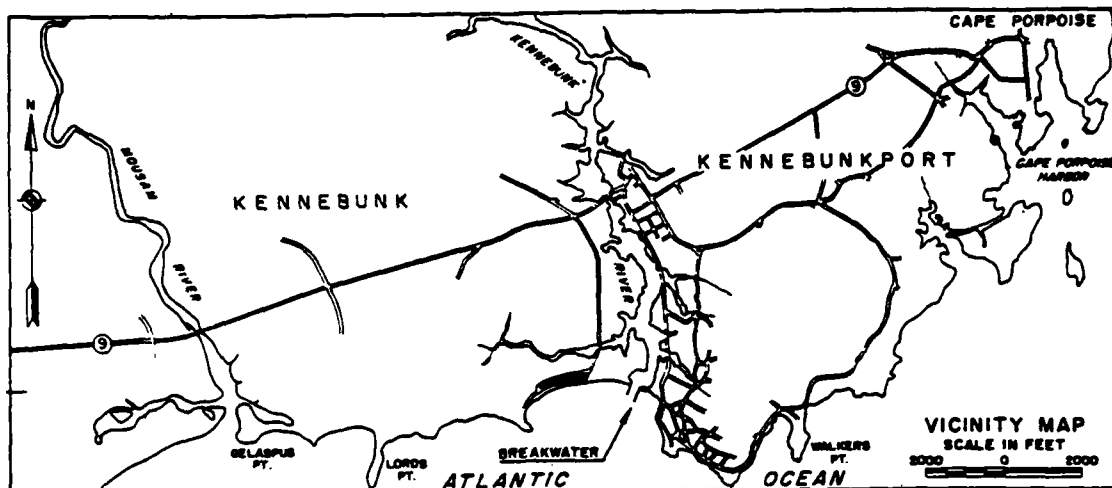
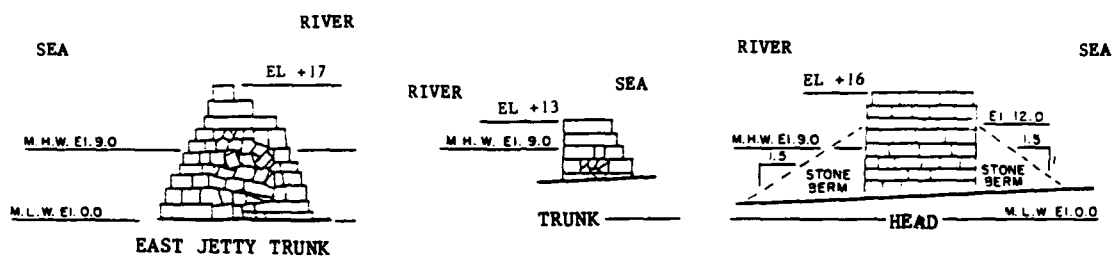
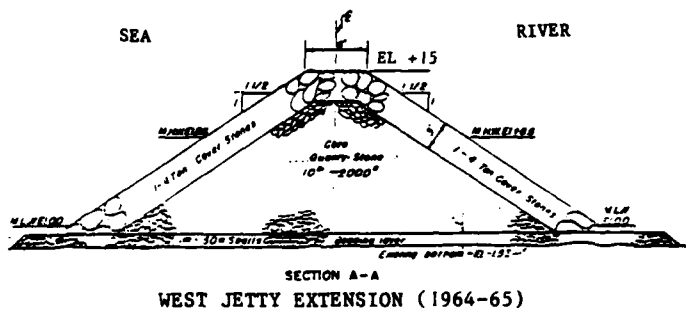
Figure 13. Plan view and typical cross sections of Kennebunk River jetties, Kennebunk, Maine

1977- 1978	Visual inspections indicated the jetties were in poor condition. On the east jetty the seaward side of the head (stone pier) was severely damaged, void spaces in the seaward slope armor stone were evident, and the channel side toe was in a deteriorated state due to undermining. On the west jetty extension the outer 150 ft had large amounts of displaced cover stone with typical elevations from +6 to +13 ft mlw. The remainder of the extension was in considerably better shape with only minor displacement and settlement of the armor stone.
1981	The jetties were repaired with armor stone along the damaged sections observed on previous inspections and a topographic survey. The channel side of the east jetty, from 1+66 to 3+80, was repaired with 5- to 8-ton stone placed to an elevation of +12 ft mlw, a 1V:1H side slope, and a top width varying from 0 to 4 ft. The east jetty's seaside was repaired between 4+20 and 5+24 using 5- to 8-ton stone

1969	Repairs were made by placing quarried stone on the east jetty seaward slope from approximately 1+00 to 5+00. Also included were repairs of an undermined channel side section between 2+50 and 2+60 and a breeched section, with a maximum depression of about 9 ft, between 3+20 and 3+50. Prior inspections between 1964 and 1967 indicated the jetty was in poor condition. The seaward slope armor stone was placed to +16 ft mlw, a minimum, composite top width of 6 ft (including the existing capstone), and a 1V:1.5H side slope. The core consisted of chips to 2,000-lb stone, and the cover layer was 5- to 8-ton stone. The damaged sections were repaired by resetting existing stone blocks and adding new stone. The design channel side slope was 1V:1H. A total of 5,600 tons of stone was placed for a cost of \$100,800. The west jetty was in good condition with only minor displacement of armor stone along the recent extension.

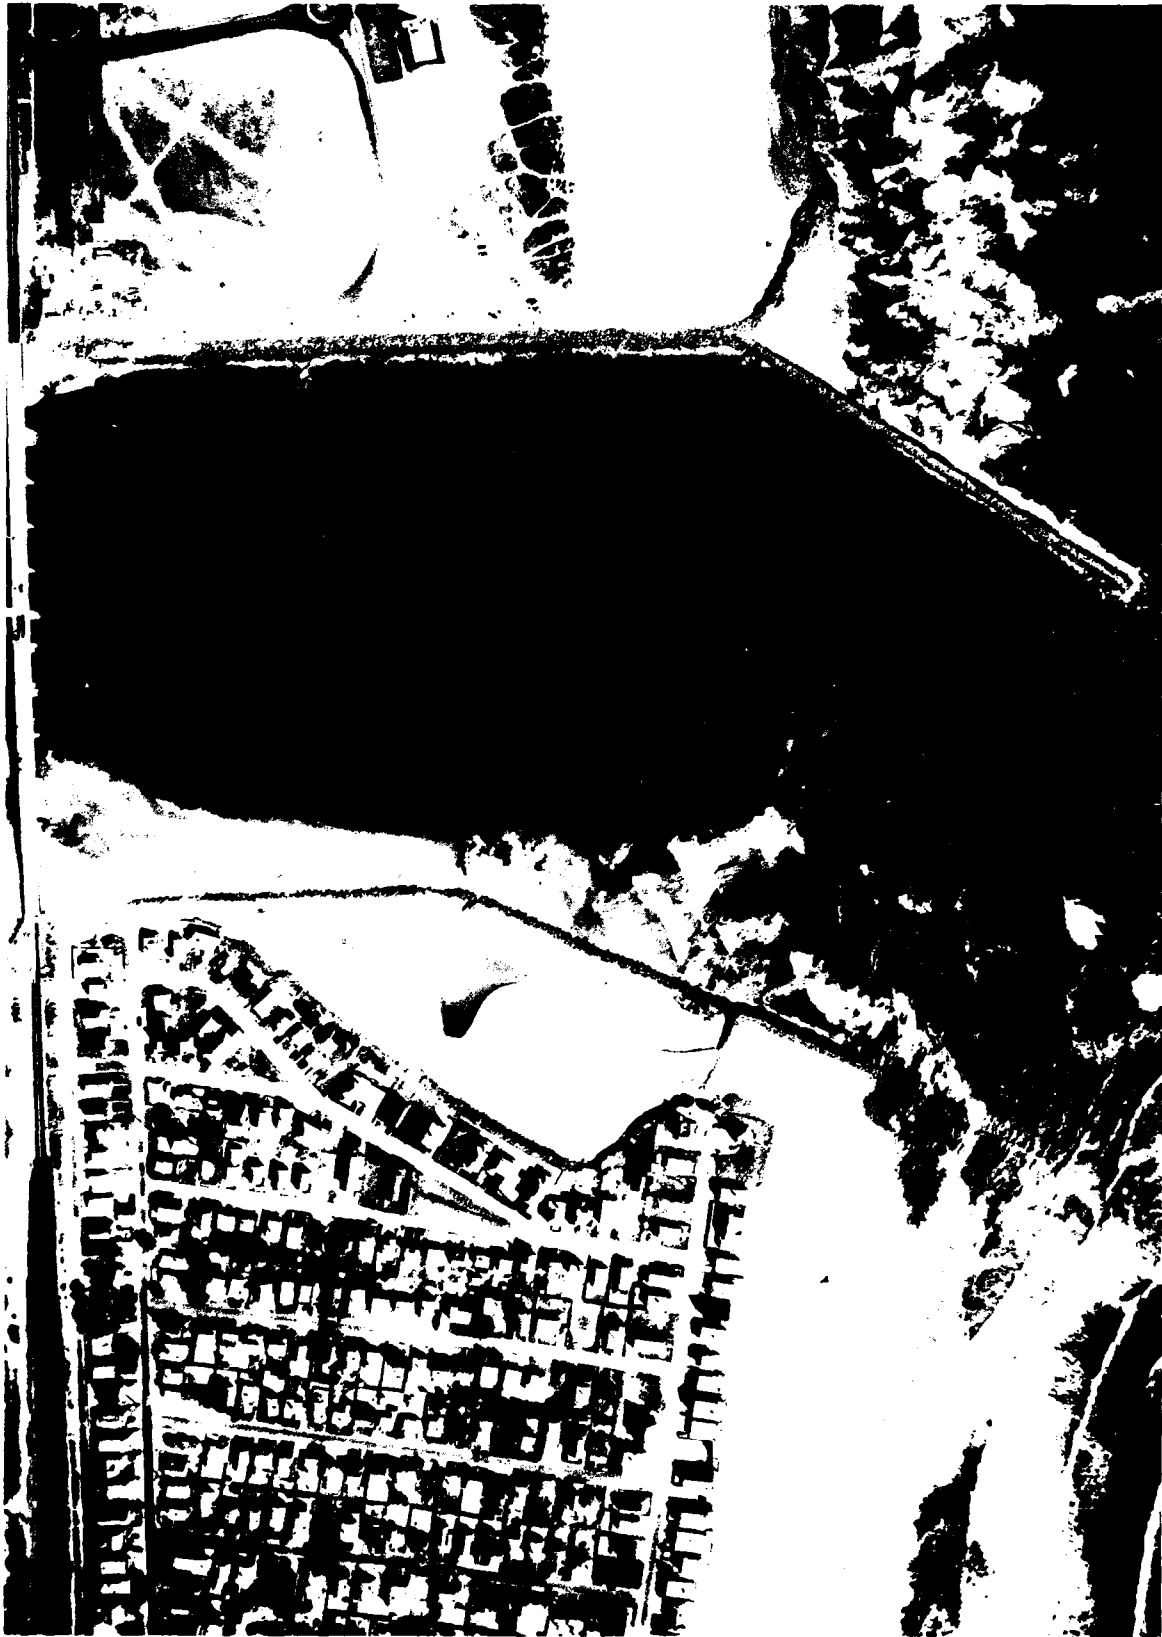
Figure 19. October 1984 photograph of jetties at Hampton Harbor, N.H.

1984	The jetties were inspected and found to be in excellent condition. Figure 19 is an aerial photograph of the jetties taken on 16 October 1984.

1969	Plans and specifications were prepared for north jetty repairs, but no work was done at this time. The outer 110 ft was in an unraveled condition with typical center-line elevations from +3 to +10 ft mlw.
1973 1974	The north jetty extension was repaired. Prior to repair, the jetty had numerous void spaces and gaps along its entire length. The seaward 300 ft was in a severely unraveled state with typical crest elevations between 0 and +10 ft mlw. The seaward 490 ft was brought up to +12 ft mlw with 6- to 9-ton stone placed to an 8- to 10-ft crown width and 1V:1.5H side slopes. The jetty head semicircle had a 1V:2H side slope. The landward 55 ft was rebuilt to the 1966 design geometry with 2- to 3-ton stone. Void areas on the remaining jetty section were repaired with 2- to 3-ton stone. A total of 8,380 tons of stone was placed at a cost of \$165,400.
1981	Repairs to the north jetty consisted of placing 4- to 9-ton stone on a 535-ft section at its seaward end. The design geometry was essentially identical to the earlier 1973-74 repair geometry. Before the repairs, typical crown elevations varied from +8 to +12 ft mlw with most of the subsidence occurring at the seaward end of the repair section. A total of 1,290 tons of stone was placed at a cost of \$109,905.

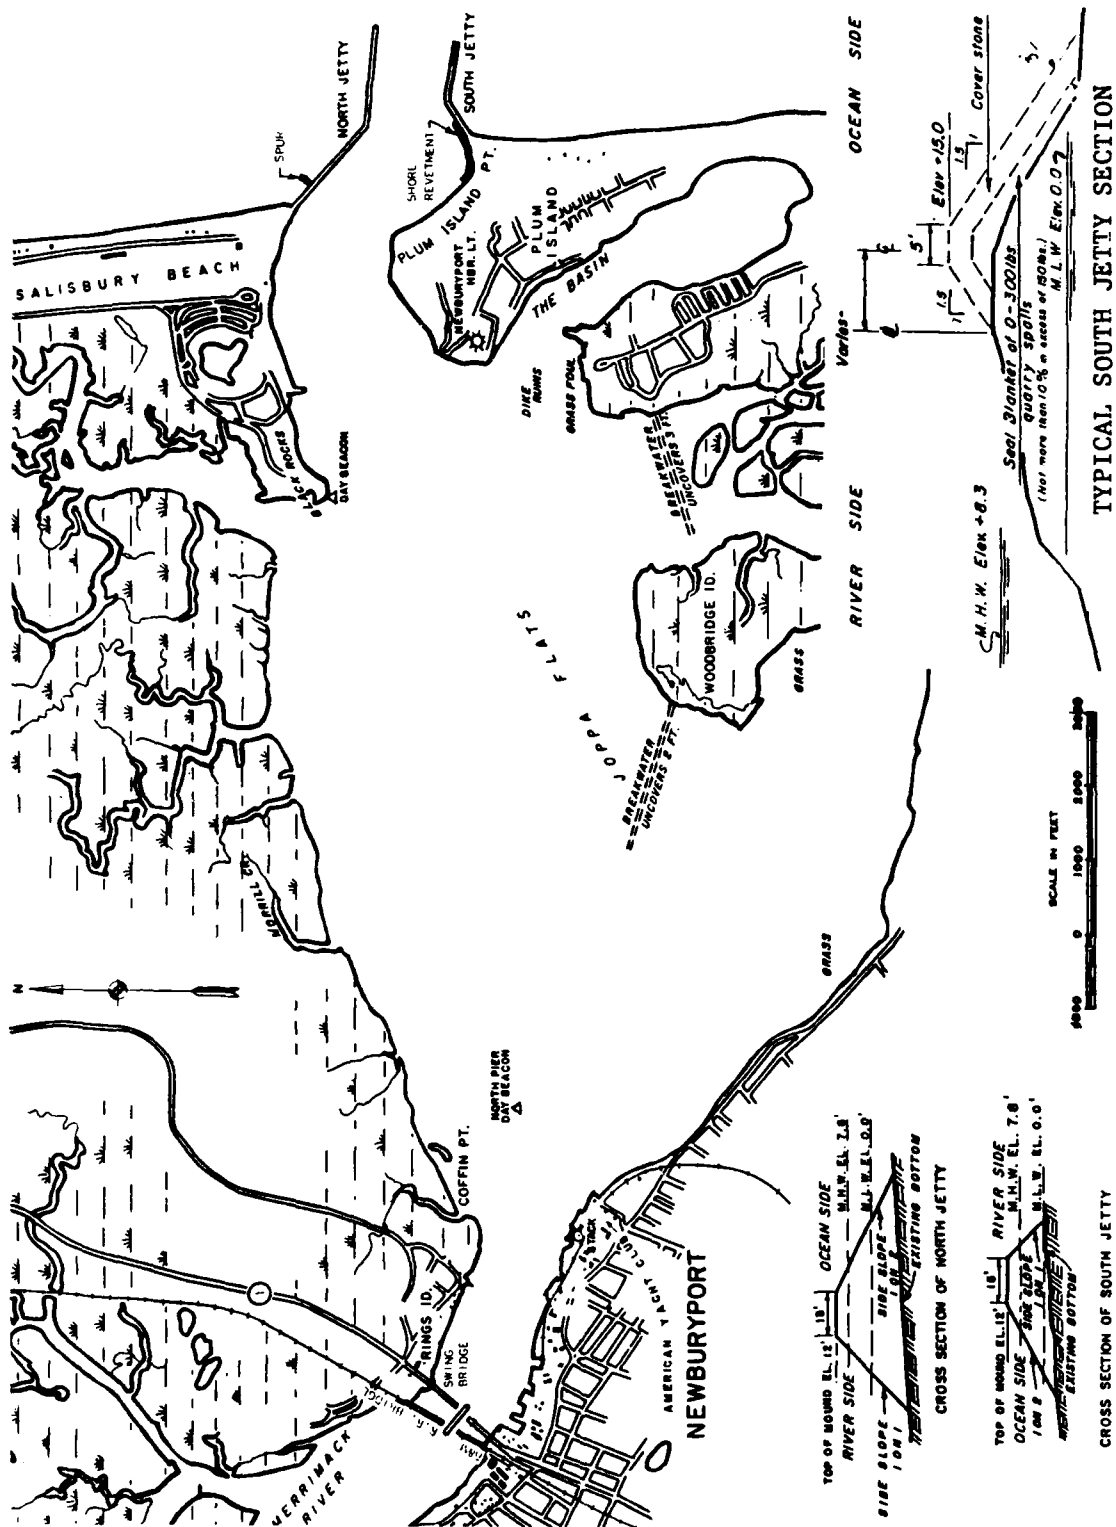
Figure 20. Location map and typical sections of jetties at Newburyport Harbor, Mass.

1963	An inspection showed both jetties were in poor condition.
1968- 1970	Extensive repairs were made to 2,920- and 1,095-ft-long sections of the north and south jetties. The repaired sections would best define the existing lengths of the jetties (Figure 20, plan view). Also completed were 700 lin ft of revetment adjacent to, and landward of, the south jetty repairs. The north jetty repairs started from its reconstructed landward end at 1+00 and continued to the existing seaward end at 30+20. The south jetty repairs started from its reconstructed landward end at 0+00, stopped at 6+00, started again at 10+05 and continued to its reconstructed seaward end at 15+00. An undetermined length of south jetty seaward of 15+00 was not repaired. Seaward of 5+50 both jetties were built up to +12 ft mlw with a 15-ft crown width and slopes of 1V:1H and 1V:2H on channel and sea sides, respectively. The landward sections (Figure 20, inset) had 1V:1.5H side slopes, a crown width of 5 ft, and maximum crown elevations of +17 and +15 ft mlw on the north and south jetties, respectively. The stone size varied from a minimum of 0.5 tons at the landward ends to a maximum of 12 tons at the seaward ends. The estimated quantity of

Date(s)	Construction and Rehabilitation History
1968- 1970 (cont.)	stone was 53,600 tons which were to be placed for a total contract cost of \$1,267,500. Similarly, the south jetty costs were \$221,500 for placing an estimated 13,500 tons of stone and 7,000 cu yd of sand and gravel.
1974	Inspections up to this time indicate the jetties were in good condition overall. Both jetties had isolated areas of settlement, with two areas on the north jetty being severe.
1983- 1987	Visual inspection of jetties indicated the jetties were in good condition.

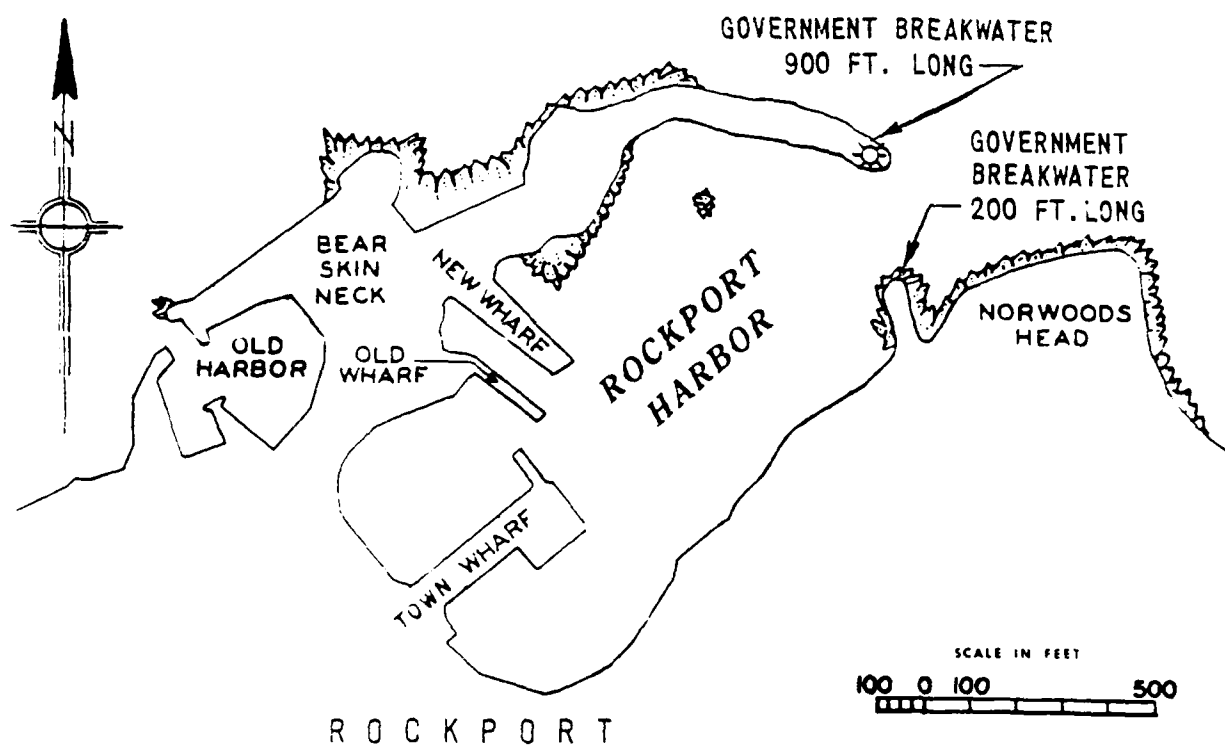
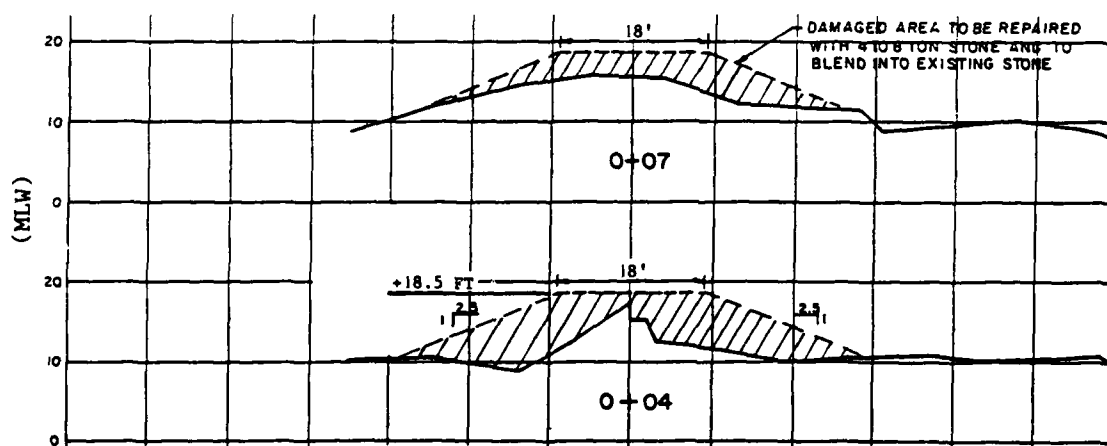
TYPICAL REPAIR SECTION (1977-78)

1970	Repairs were made at the seaward end of Bearskin Neck breakwater where stone had been displaced from a lower portion of the head side slope. The existing head section cover layer had a fairly smooth appearance due to careful placement and addition of concrete grout. Also, iron tie rods had been placed, connecting individual cover stone throughout this section. The remainder of the breakwater is composed of 500-lb to 5-ton stone with an outward appearance typical of rubble-mound structures. The 45-ft-long repair section was located mostly on the harbor side quadrant of the head. Stone weighing 5 to 8 tons was placed at a 1V:2H side slope. The repairs were made for a lump sum of \$25,500.
1973	The seaward end of Bearskin Neck breakwater was repaired with 5- to 8-ton stone. The stone was placed on two sections, one totaling 55 ft in length on the seaside head and trunk and the other totaling 50 ft in length, the same area repaired in 1970. The repairs consisted of adding stone to void areas such that the resulting side slopes were fairly uniform. Lump sum cost of the repair was \$28,700.

1977- 1978	Repairs were made to the seaward 100 ft of Bearskin Neck breakwater. Existing displaced stone was reset throughout this section and, to complete the repairs, approximately 1,600 tons of new 4- to 8-ton stone were used. The repair geometry had a +18.5 ft mlw crown elevation, a crown width varying from 18 to 28 ft (widest at seaward end), and side slopes varying from 1V:2.5H to 1V:1.5H (steepest at
